## Saybrook Stormwater Management Basin Inspection Summary

SEA #: 6431-SAYB

June 28, 2018

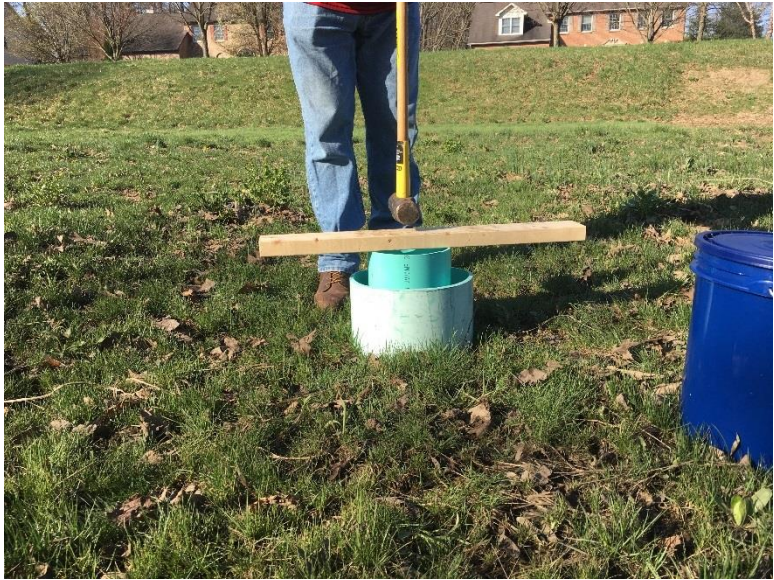
**Photo 1**

Ring diameters of 12 inches and 6 inches were used for the double ring infiltration tests. The rings were driven into the ground at least 4 inches.

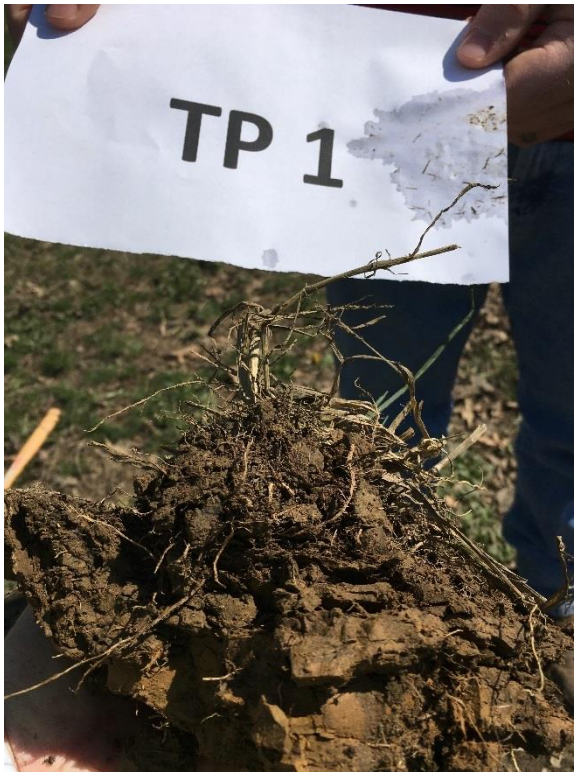
**Photo 2**

There is little to no topsoil at test pit 1. The soil is very clayey and breaks apart into large, angular chunks.

- Within the lower area of the basin, modification should be made to restore infiltration:
  - Remove approximately 7" of clayey soil,
  - Till basin bottom,

- Place a minimum of 5" of topsoil (there is no depth of topsoil noted on the design plan, but a minimum of 4-6" is required/industry standard to support grass growth), and

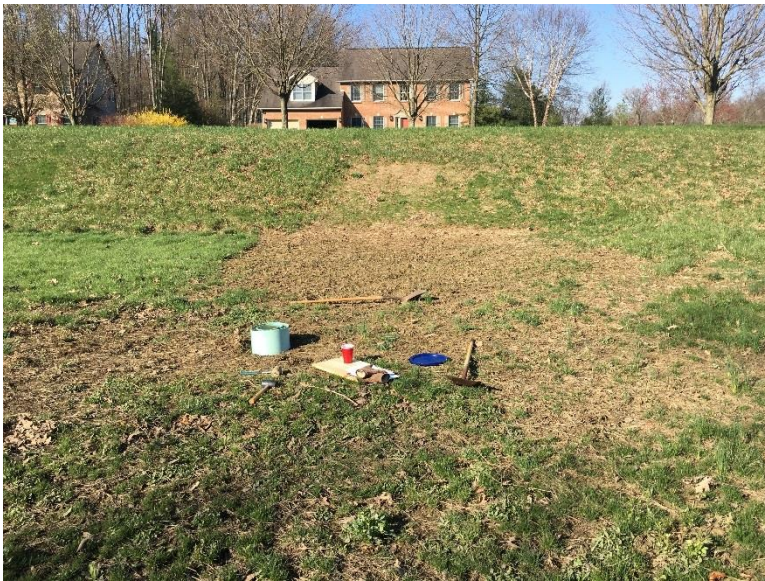
**Photo 3**

Infiltration test 1 was conducted in an area that had been disturbed during a basin repair conducted in the summer of 2017.

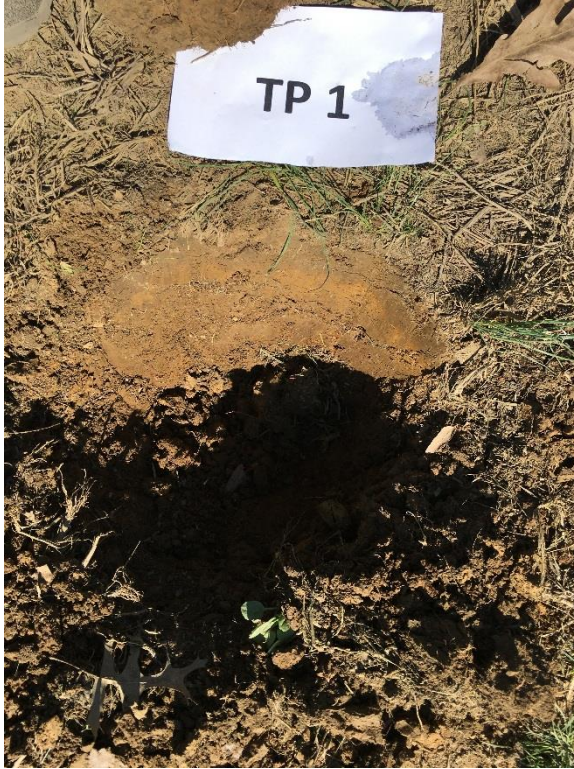
**Photo 4**

The soil profile shows nearly no top soil and clay smear from the shovel.

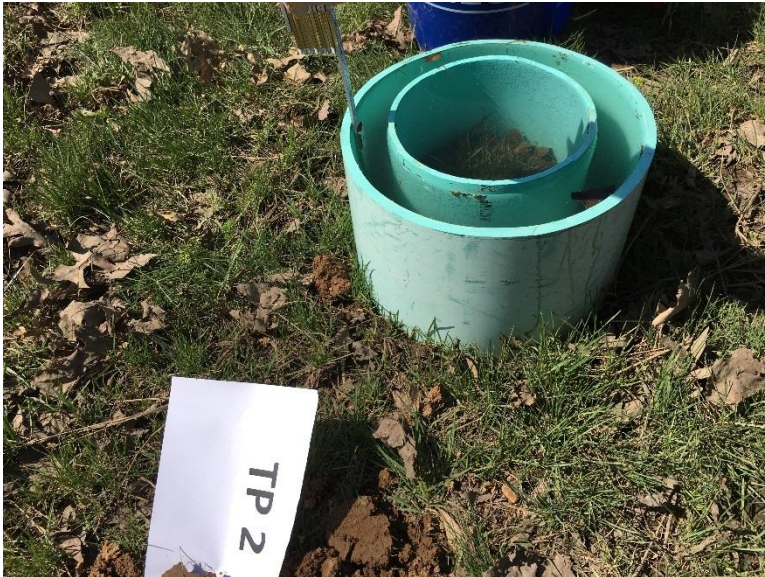
**Photo 5**

Based on the rate of fall during the pre-soak, an infiltration testing time interval of 30-minutes was used for all test pits in Basin 2. The average drop in water level at TP 2 over the 30-minute interval was 0.23 in.

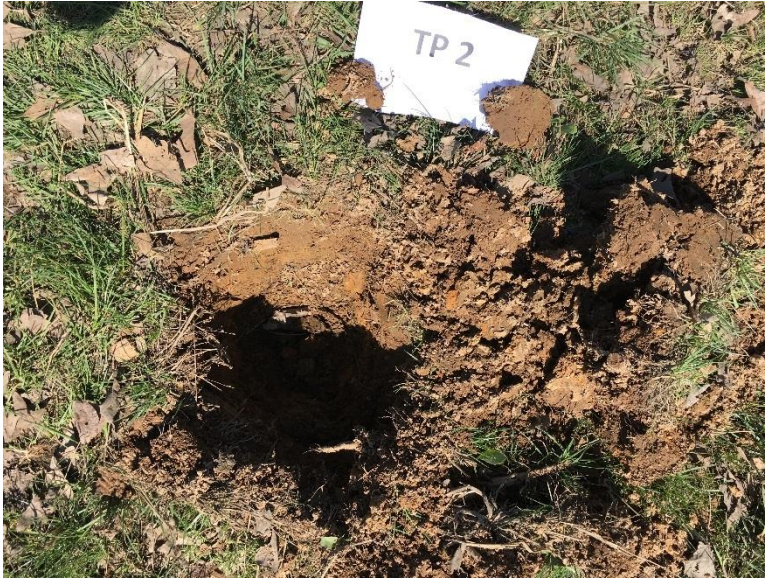
**Photo 6**

The soil profile at TP 2 shows nearly no top soil.

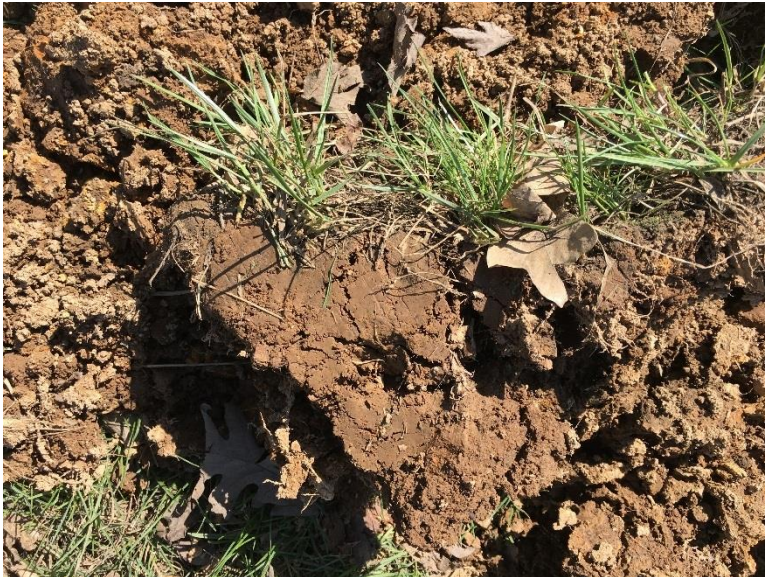
**Photo 7**

A soil clod from the ground surface at TP 2 shows no top soil.

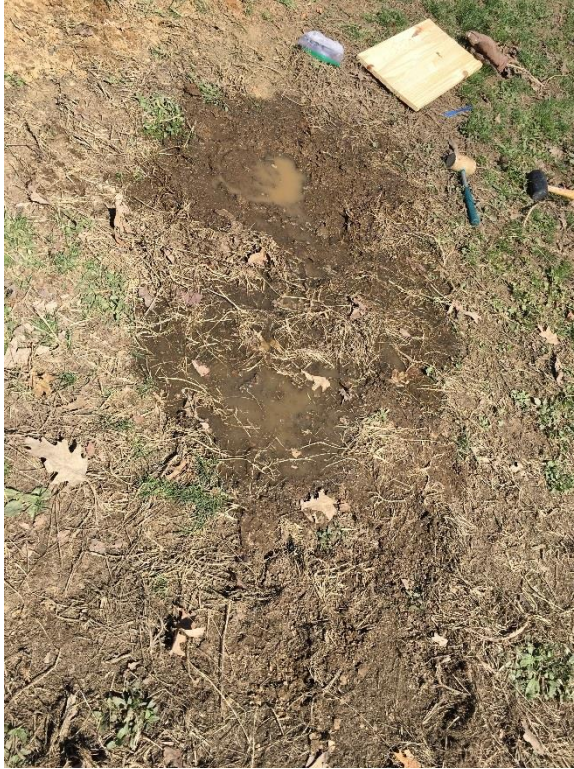
**Photo 8**

More than 15 minutes after the rings were removed from the ground at TP 3, water continued to lay at the surface and runoff rather than infiltrate.

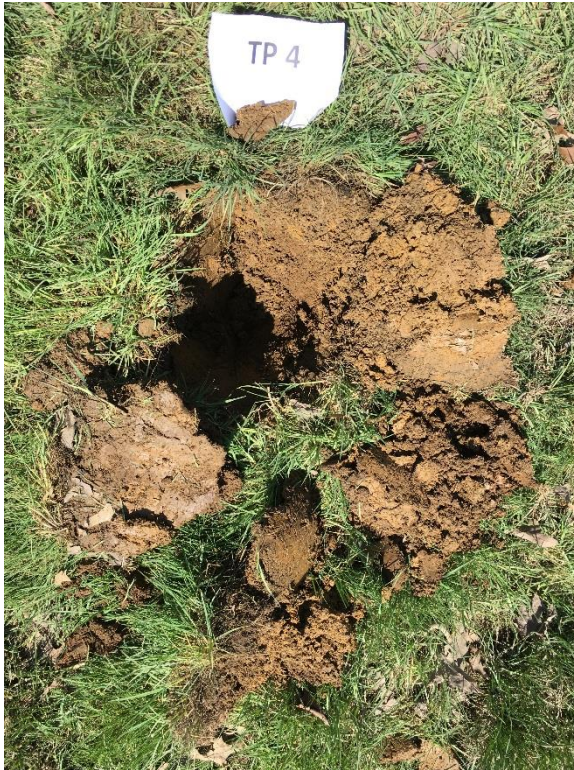
**Photo 9**

There is a higher density of grass at TP 4 than there is in other areas within the infiltration area of Basin 2. Although there is still little topsoil, the soil is less compacted and there is a looser soil structure as compared to TP 1, 2, and 3. The average drop in water level over 30-minutes was 0.8 inches.

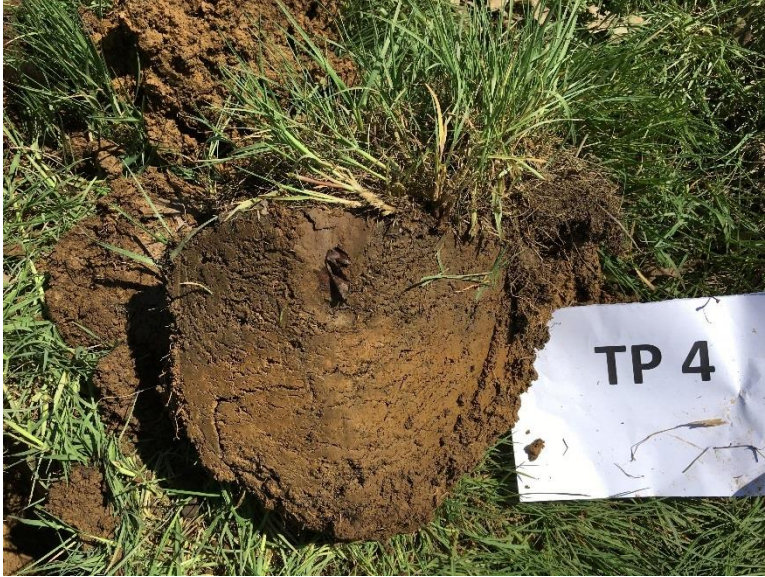
**Photo 10**

A soil clod from the surface at TP 4 shows a darker top layer, which indicates a higher content of organic material.

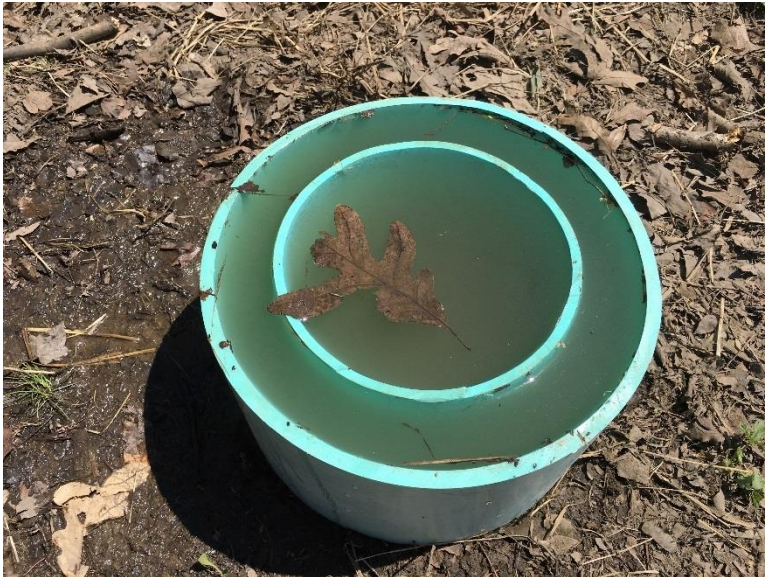
**Photo 11**

TP 5 is in the general vicinity of basin work completed in the summer of 2017. This location had the lowest infiltration rate in Basin 2. The average drop in water level of the 30-minute test interval was 0.06 inches

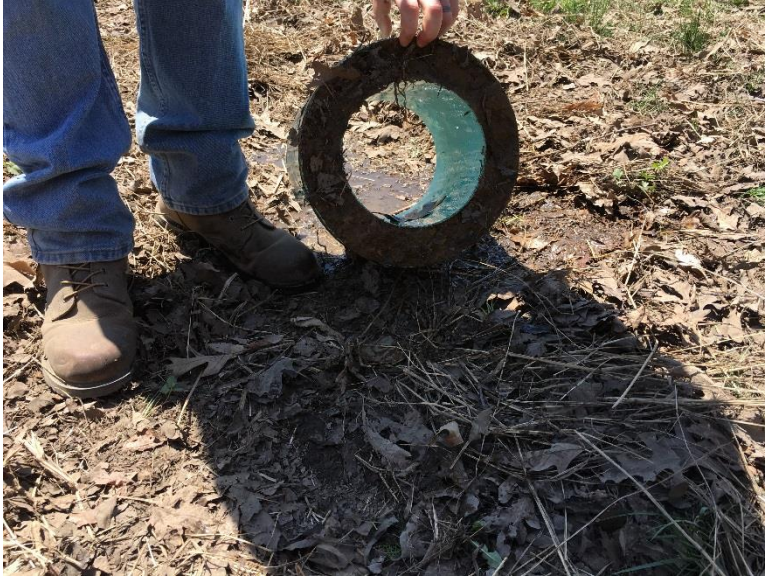
**Photo 12**

After the test was completed at TP 5 and the rings were removed from the ground, the rings remained clogged with a chunk of clay that was pulled out with the testing equipment.

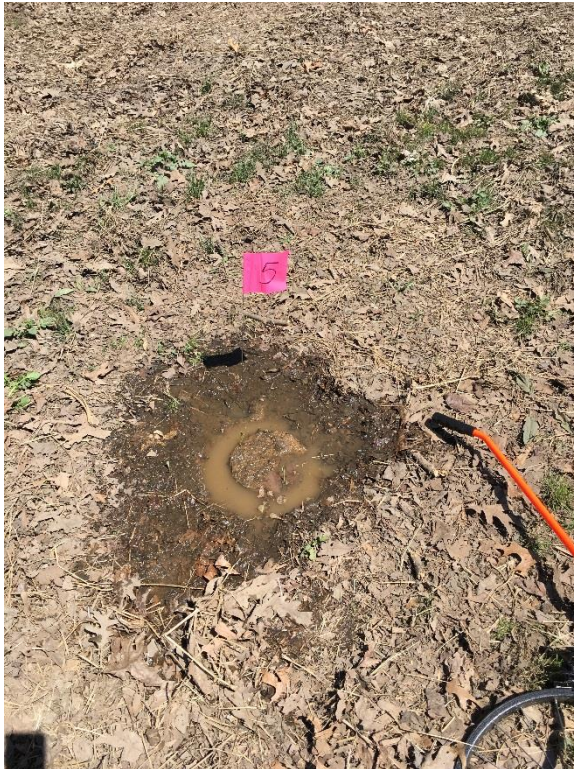
**Photo 13**

Following the testing at TP 5, water continued to sit in the depression created by the rings and did not infiltrate.

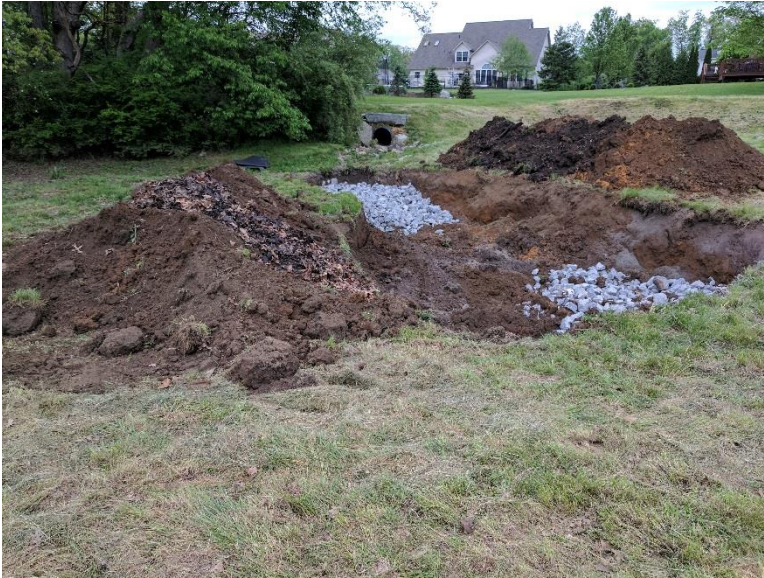
**Photo 14**

Modifications to Basin 2 were observed on 5/22/17. An area was excavated with soil stock piled in the Basin while aggregate was placed in the hole.

- The HOA should be provided with all documentation for the modifications made during the summer of 2017, including the reason for conducting the repairs, the design methodology for the repairs and any documentation of the resulting condition from the repairs.

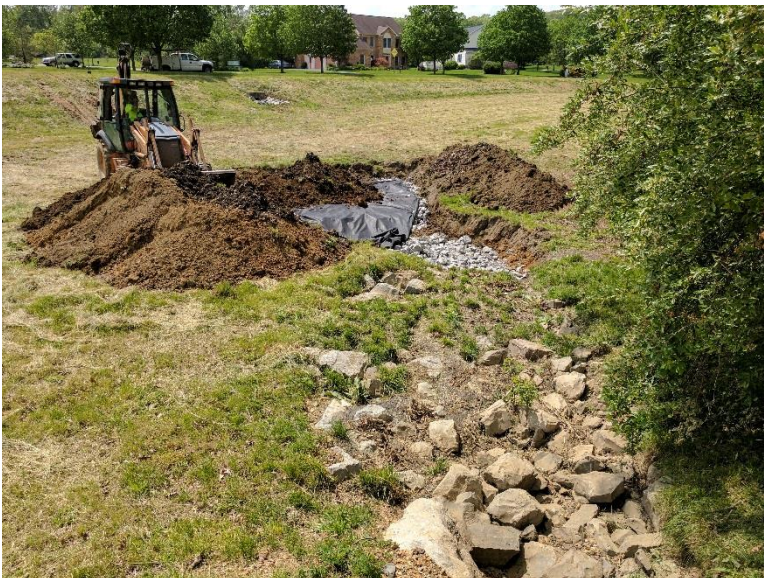
**Photo 15**

During the 5/22/17 modifications, the placed aggregate was covered with a fabric and then the soil was replaced.

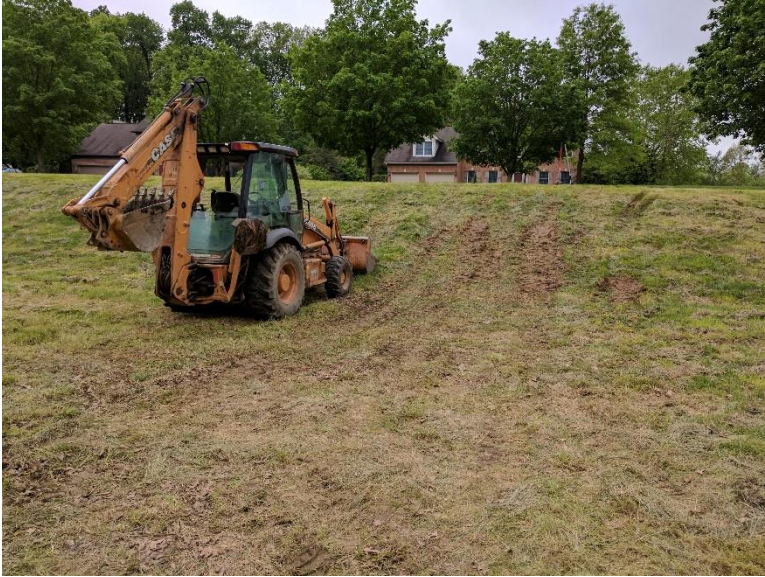
**Photo 16**

There was a light rain on 5/22/17. Equipment rutted the basin embankment and floor.

- Vegetate to achieve a uniform 70% perennial vegetative cover per PA Code Ch 102.22(a)(2)(ii).
- Do not run construction equipment across the basin bottom, except as shown in the original construction documents or per a revised construction plan sealed by a professional engineer.

- Do not preform work while soil is wet.

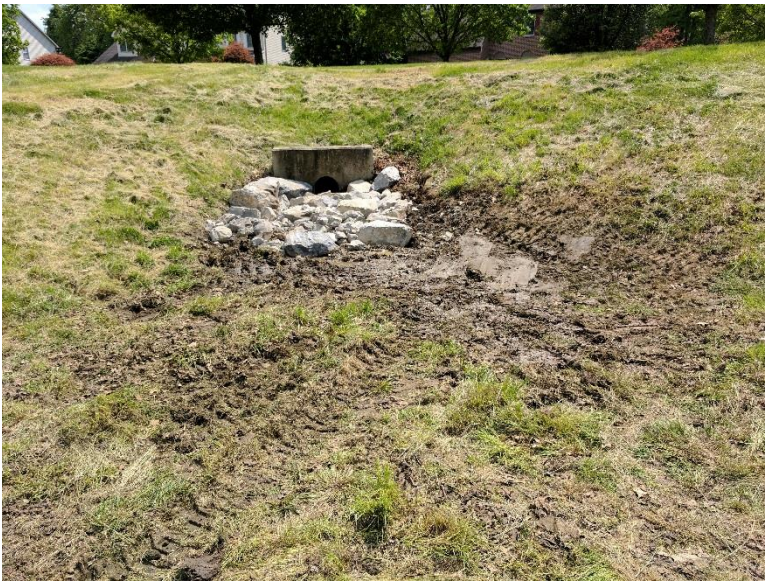
**Photo 17**

During the 5/22/17 modifications, stone was placed at the southeast inflow pipe. Equipment left rutting in the vicinity of the work.

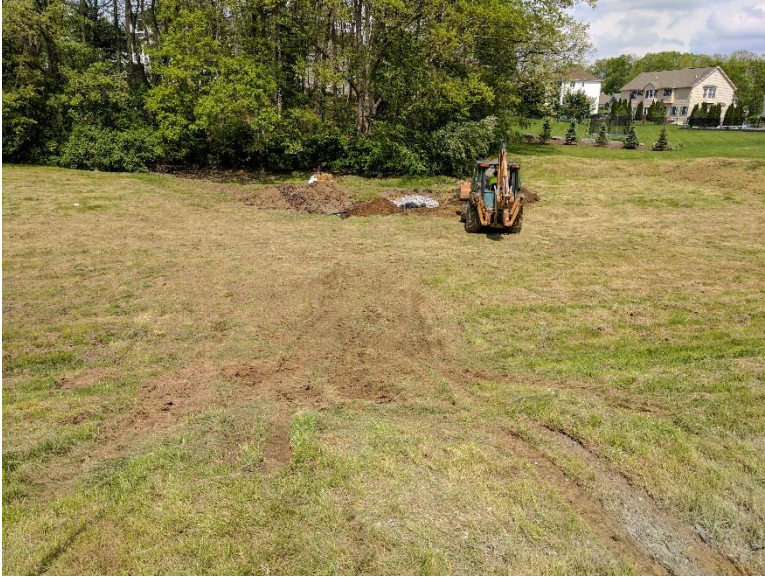
**Photo 18**

During the 5/22/17 modifications, rutting from equipment can be seen in the Basin embankment and bottom in the area of the basin that is designed for infiltration.

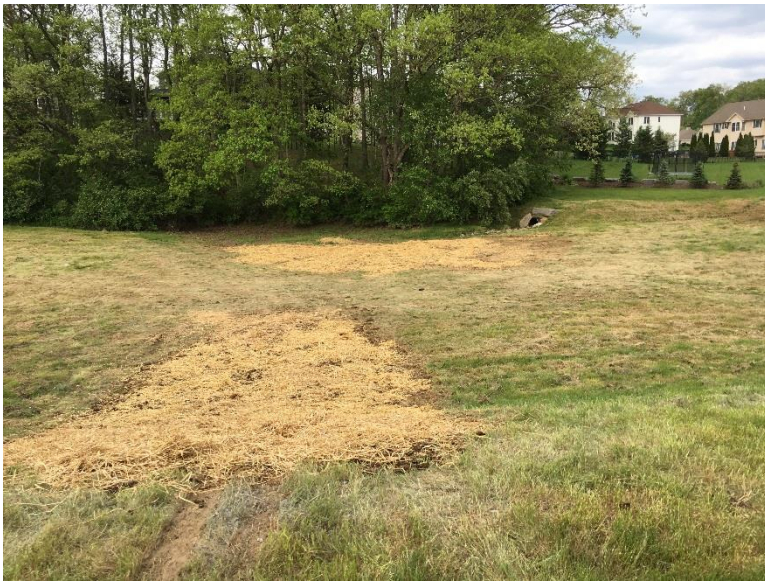
**Photo 19**

At the end of work day on 5/22/17, the disturbed areas were covered with straw. It is not known if the areas were also seeded.

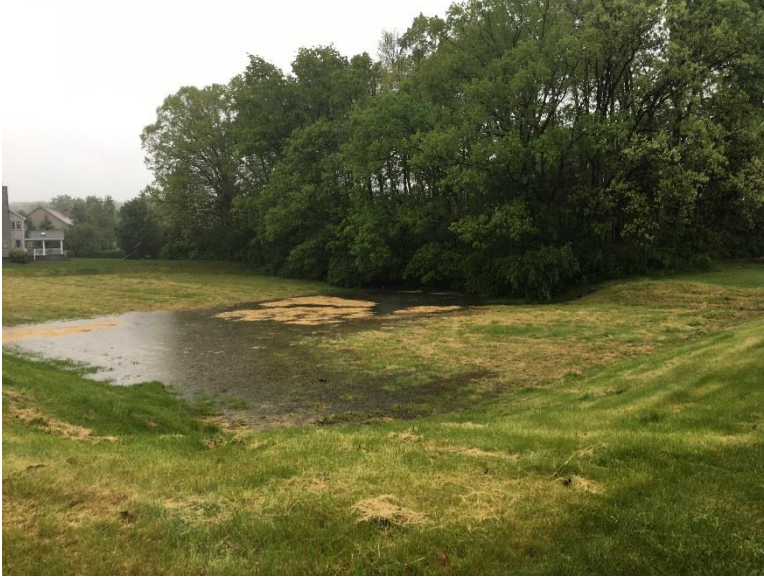
**Photo 20**

Three days after the Basin 2 modification, a rain storm washed away straw (5/25/17).

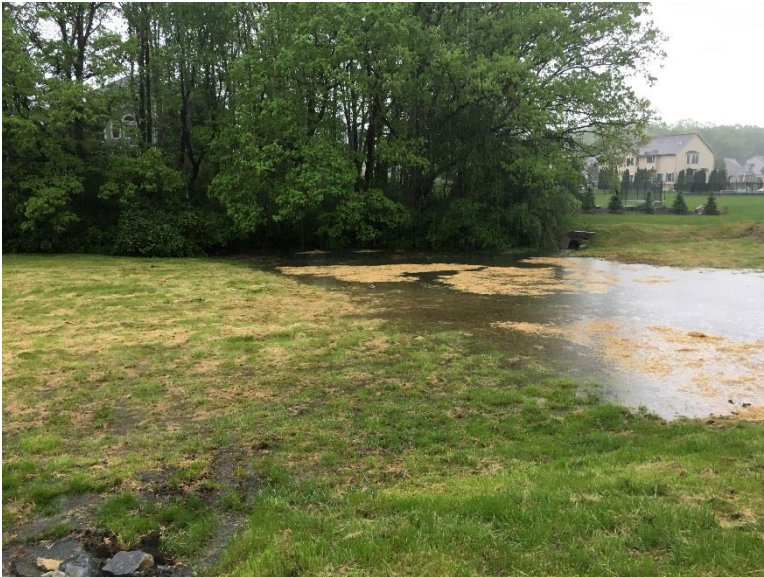
**Photo 21**

Three days after the Basin 2 modification, a rain storm washed away straw (5/25/17).

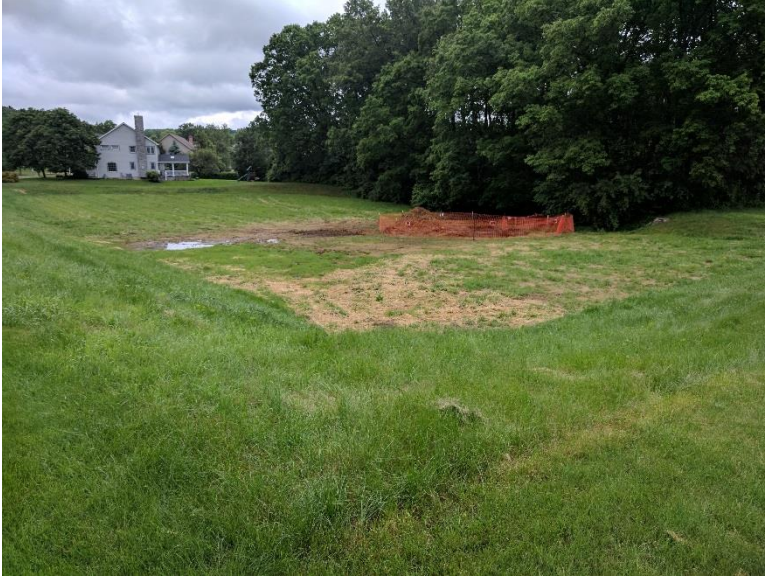
**Photo 22**  
Additional basin modification  
were completed on 6/7/17

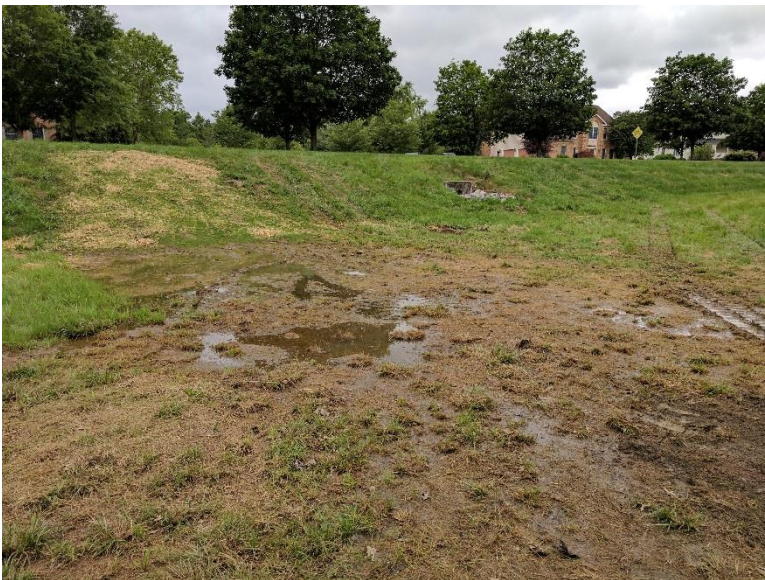
**Photo 23**  
The embankment area that had  
already been disturbed on 5/22  
was further disturbed 6/7/17.  
There was a light rain which  
would have increased soil  
compaction

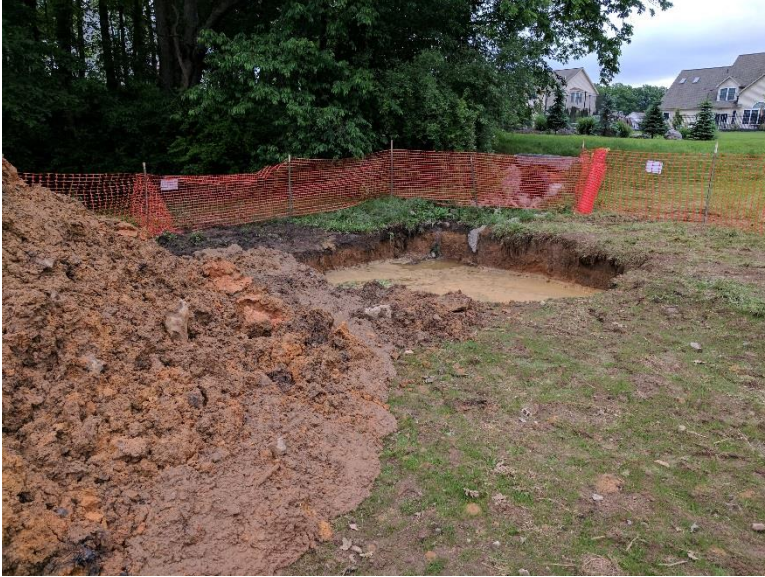
**Photo 24**

During the 6/7/17 modifications, the excavated area filled with water. Excavated material was stock piled in the basin, which would increase the likelihood on compaction of the soil below.

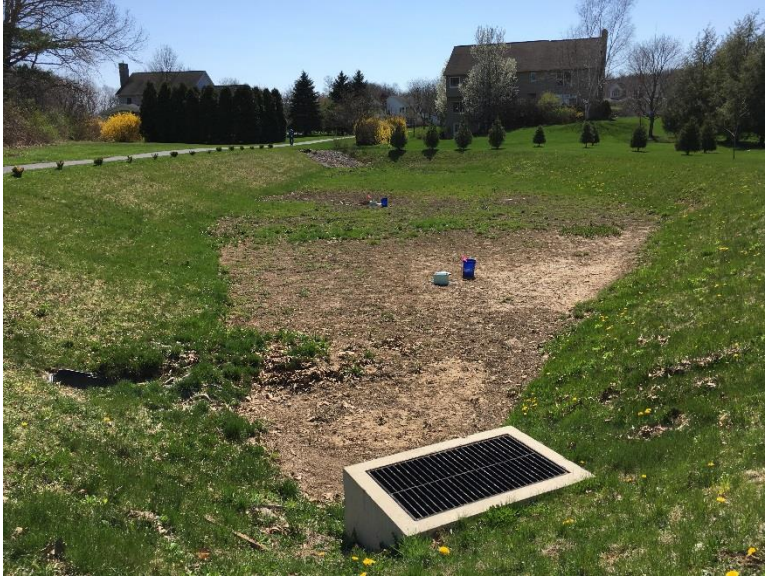
**Photo 25**

At permit termination basin should have 70% vegetation cover. Basin 3 does not meet this criteria.

- Vegetate to achieve a uniform 70% perennial vegetative cover per PA Code Ch 102.22(a)(2)(ii).
- Place riprap at the outlet of the northeast inflow pipe as noted on Saybrook Final Subdivision Plan Phase 10, Post Construction Stormwater Management Plan, Sheet No PSCM 1, dated 3/31/14.

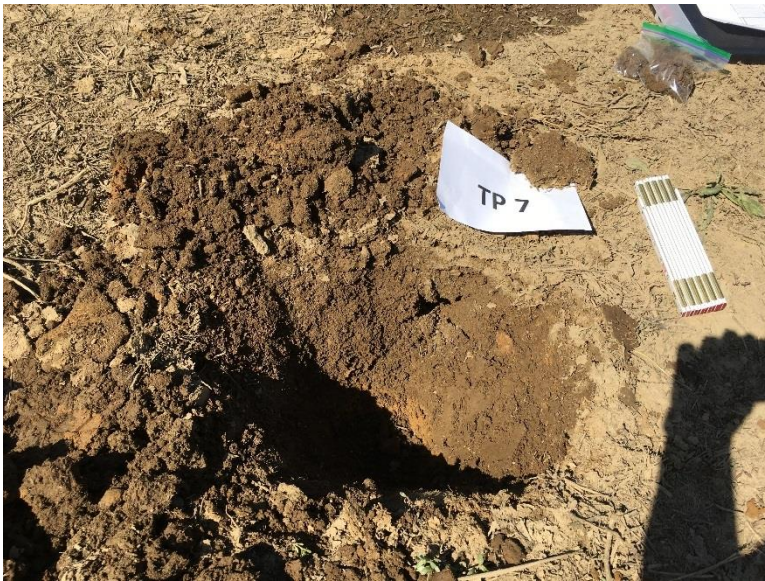
**Photo 26**

Test pit 7 shows a clay soil with a very dry surface layer.

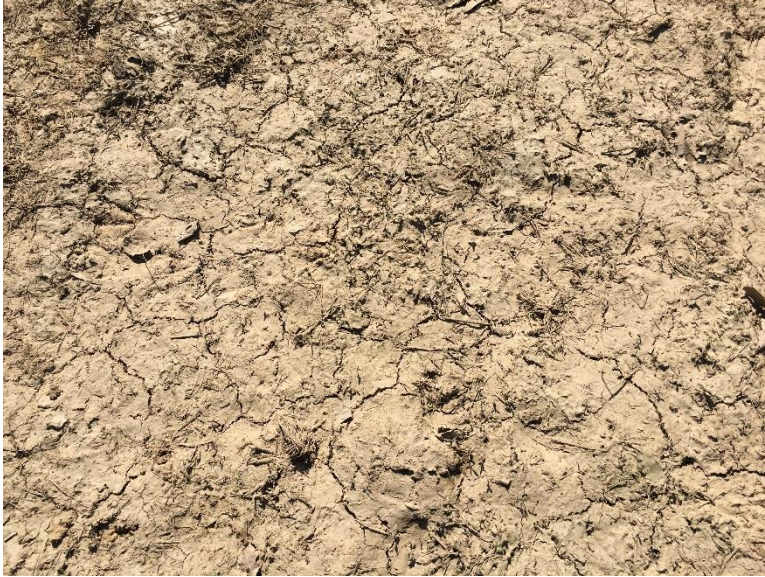
**Photo 27**

The lower portion of the basin bottom is caked with sediment and is not likely to grow vegetation without soil amendment and plantings.

- Clean around outlet structures. Remove leaves and other dead vegetation
- Modification should be made to restore infiltration:
  - Remove approximately 8" of clayey soil,

- Till basin bottom,
  - Place 6" of topsoil per Saybrook Final Subdivision Plan Phase 10, Post Construction Stormwater Management Plan, Sheet PSCM 2, dated 3/21/14.

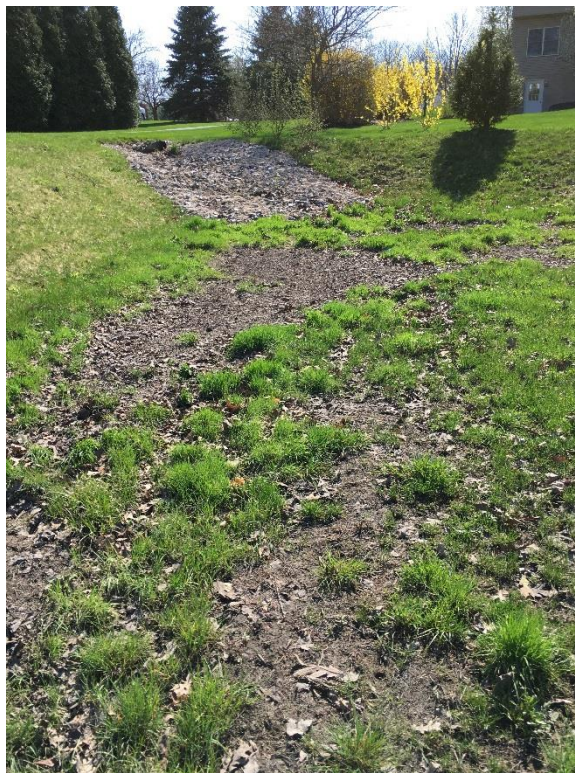
**Photo 28**

Vegetation in the upper portion of the basin is patchy with bare areas.

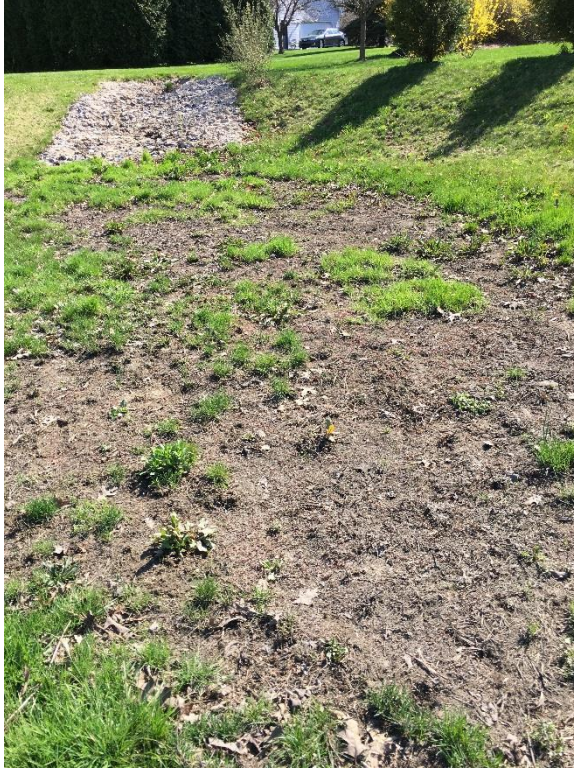
**Photo 29**

Vegetation in the upper portion of the basin is patchy with bare areas.

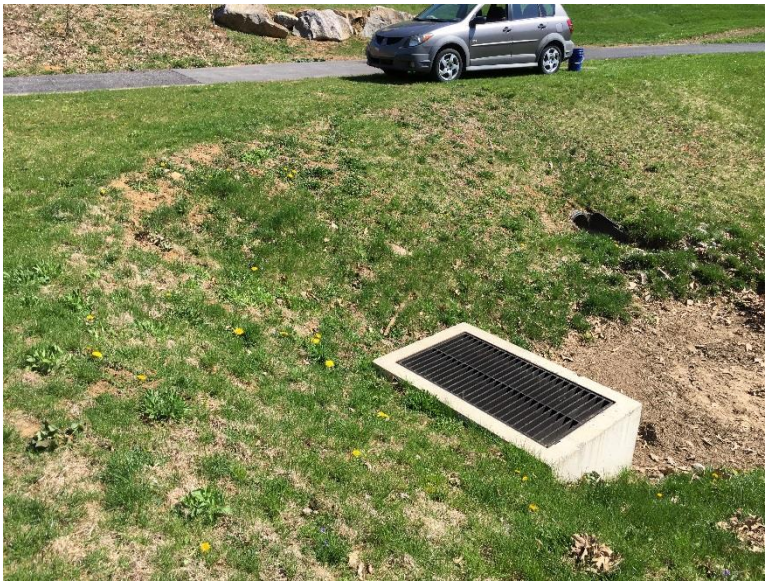
**Photo 30**

There are bare spots of soil around the embankment and outlet structure. Erosion of soil is likely here.

- Establish vegetation around the embankment of the basin
- Establish vegetation in the outflow channel. May need to include reinforcing if slopes are too steep for stabilization with vegetation alone. (Design for channel was not reviewed as part of this report.)

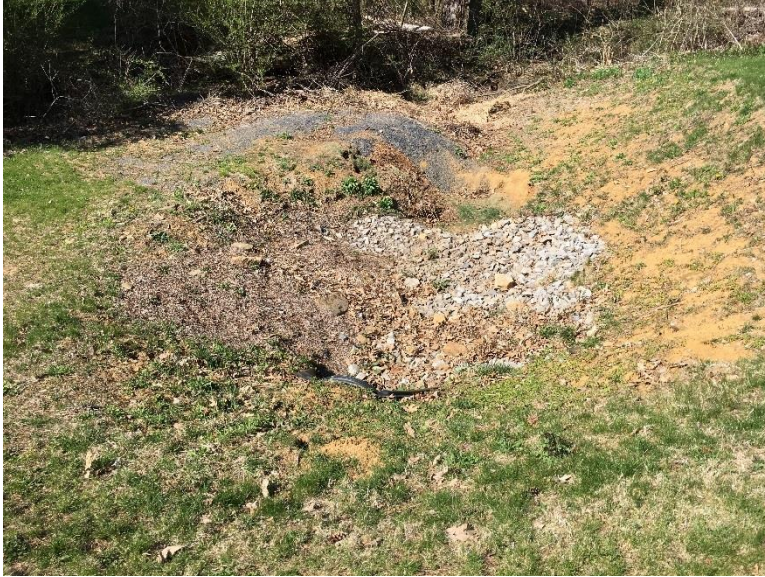
**Photo 31**

The outlet channel is not stabilized with vegetation and further erosion is likely to occur.

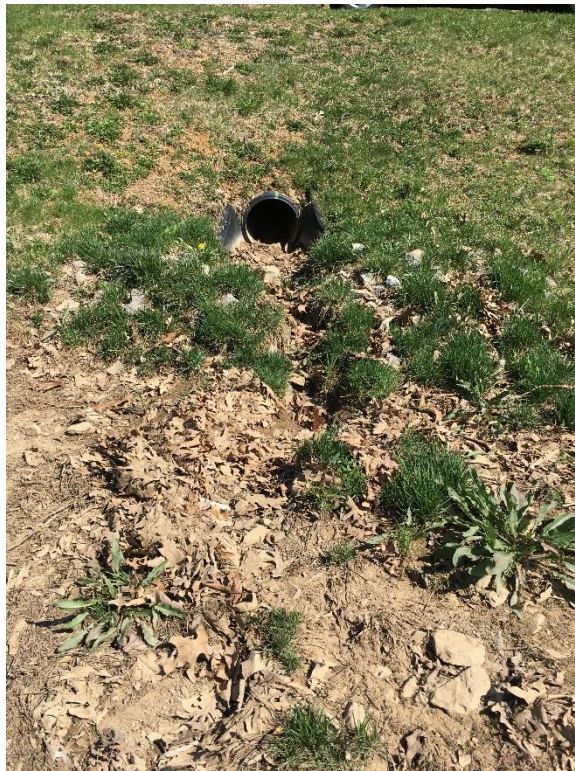
**Photo 32**

The inflow pipe toward the northeast shows channelization and further erosion is likely.

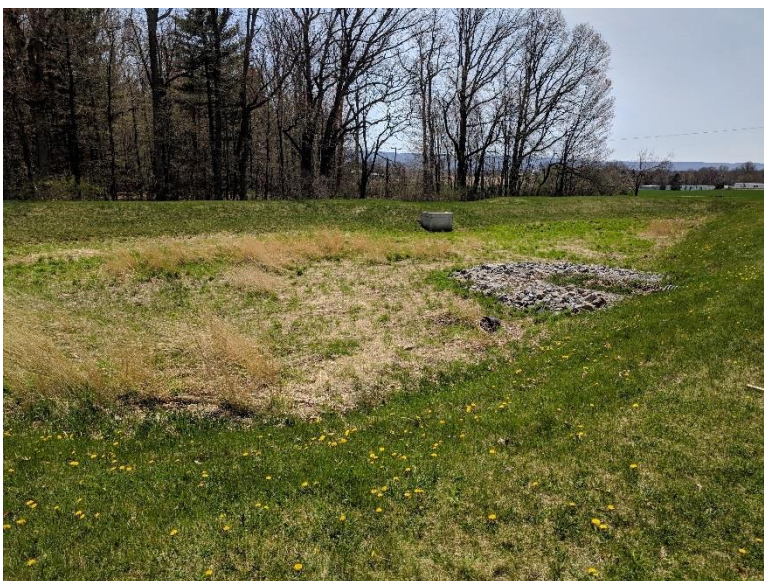
### Photo 33

Basin 4 is vegetated with a mix of different grasses but also has bare patches.

- Clean around outlet structures. Remove leaves and other dead vegetation.
- Establish permanent vegetation in areas of bare soil to meet a uniform 70% vegetative cover per PA Code Ch 102.22(a)(2)(ii).

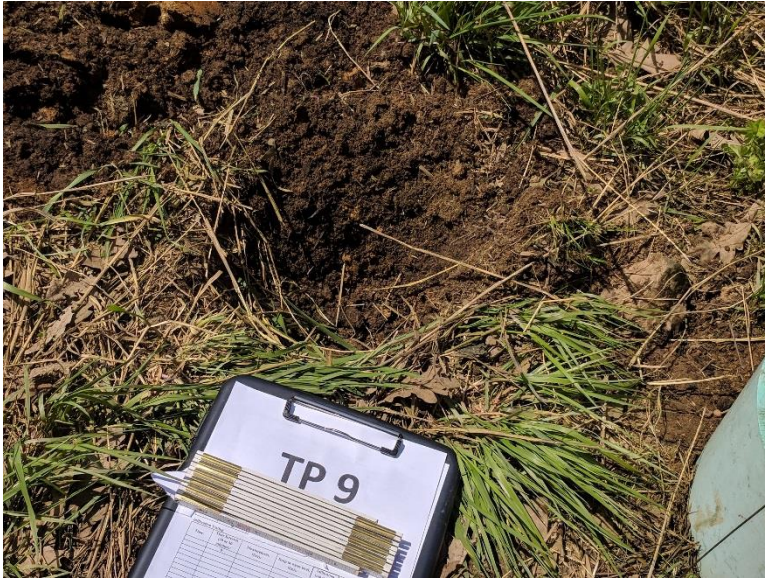
**Photo 34**

Test pit 9 shows more top soils and a looser soil structure than in the pits within Basins 2 and 3.

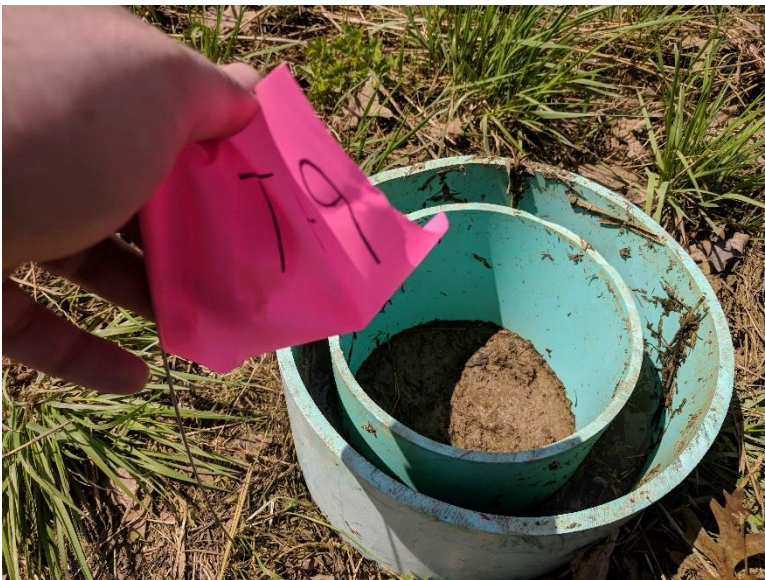
**Photo 35**

TP 9 ran dry during the pre-soak period so the 10-minute test interval was used.

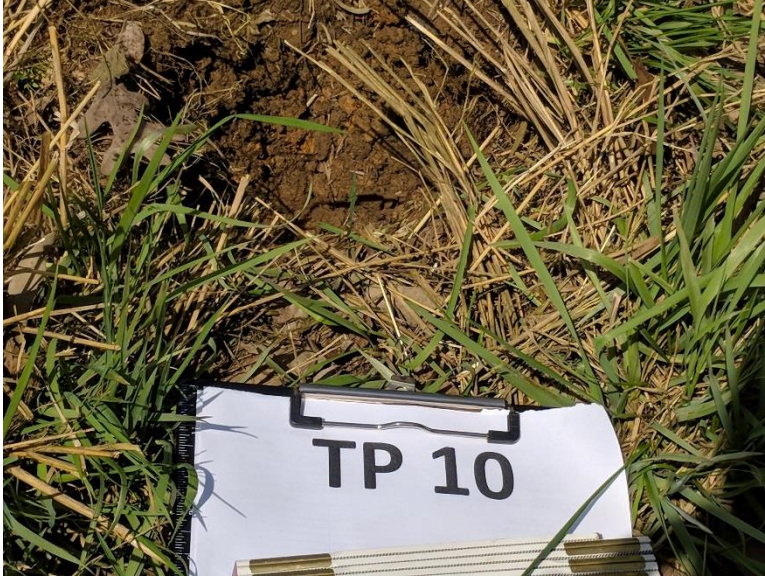
**Photo 36**

Test pit 10 shows more top soils and a looser soil structure than in the pits within Basins 2 and 3.
