## Saybrook Stormwater Management Basin Inspection Summary

SEA #: 6431-SAYB

June 28, 2018

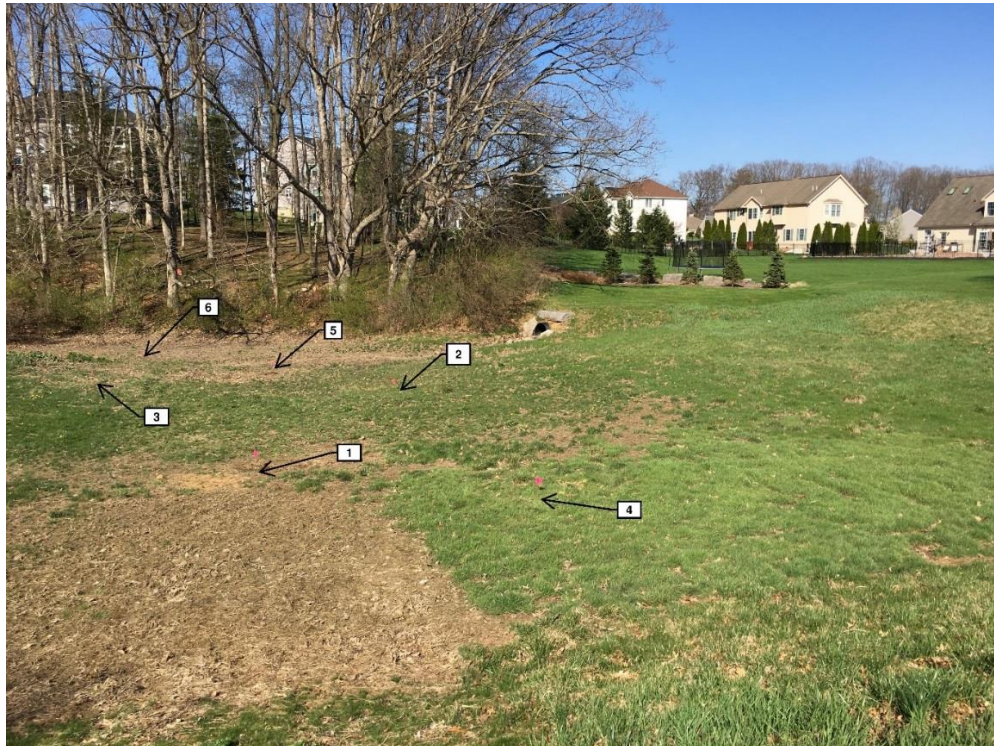
Figure 2. Test pit/infiltration test locations within the eastern, infiltration area of Basin 2.

Test pits and infiltration tests were confined to the eastern part of the basin where infiltration is a primary function. Figure 2 shows the locations of the test pits within the infiltration area of Basin 2. Photos 2-13 document the basin condition and testing observations. The average infiltration rate for Basin 2 was 0.61 in/hr.

As can be seen in the photos and reflected in the infiltration data, there has been some compaction of the soil in Basin 2. Some of the surface area of the Basin bottom are bare, without vegetation. During the summer of 2017, Sweetland twice observed modifications to the Basin 2 made within the lower portion of the basin. Construction equipment was in the basin bottom and material was stock piled which would have compacted soil and removed or killed vegetation. Photos 14 – 22 document observations of basin modifications

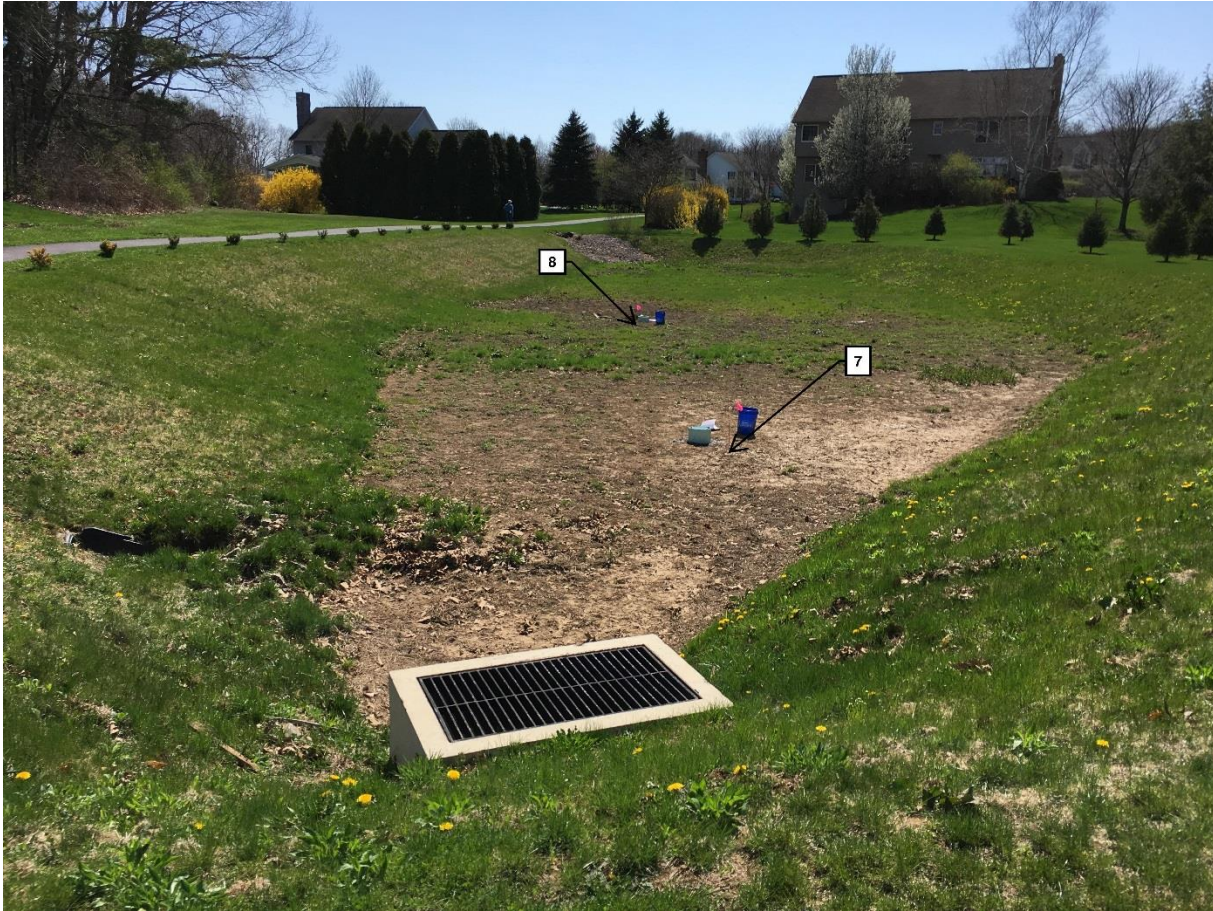
Figure 3. Test pit/infiltration test locations within the Basin 3.

Infiltration testing in Basin 3 was conducted on 5/2/18. According to the design plans this basin was designed to have infiltration across the entire bottom. Figure 3 shows the locations of the test pits within the infiltration area of Basin 3. Photos 25-32 document the basin condition and testing observations. The average infiltration rate for Basin 3 was 0.12 in/hr.

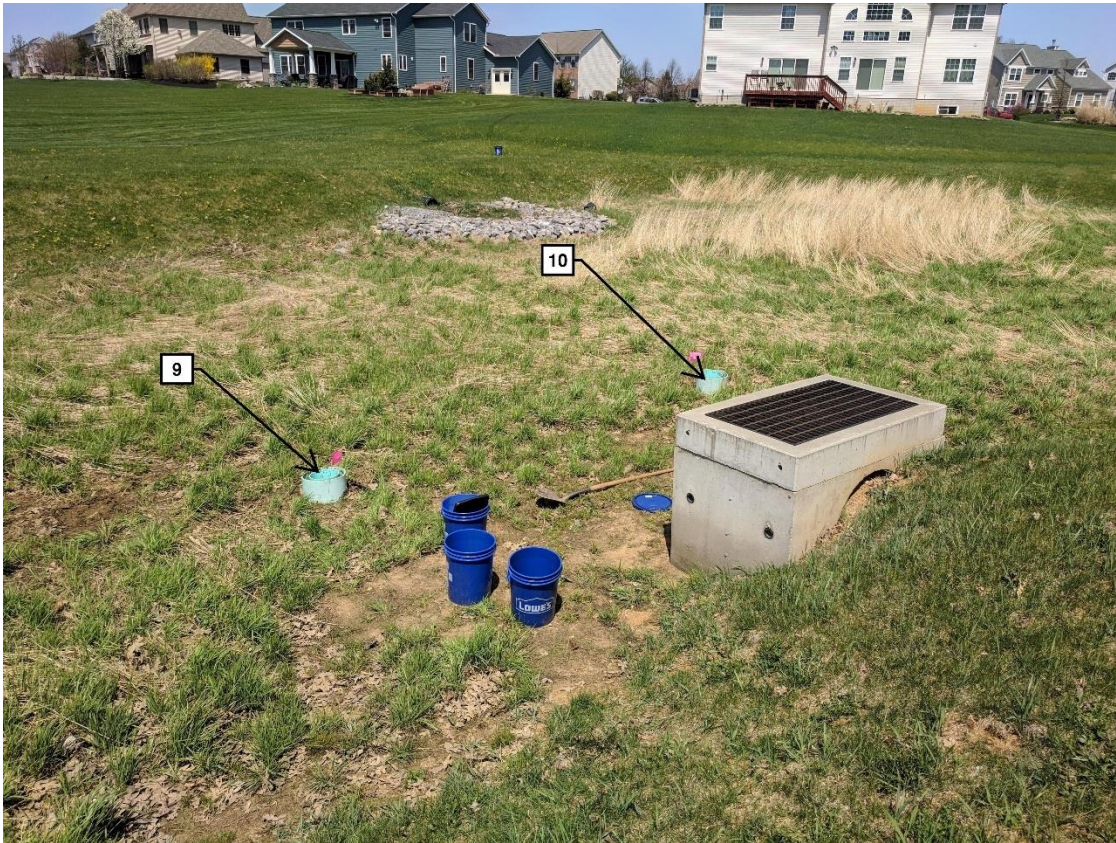
Figure 4. Test pit/infiltration test locations Basin 4.

Infiltration testing in Basin 4 was conducted on 5/3/18. According to the design plans, the basin has been designed for infiltration across the bottom. Figure 4 shows the locations of the test pits. Photos 33-36 document the basin condition and testing observations. The average infiltration rate for Basin 4 was 9.32 in/hr.
